## APPLICATION NOTE

### Frequently asked questions about the Plena Voice Alarm System

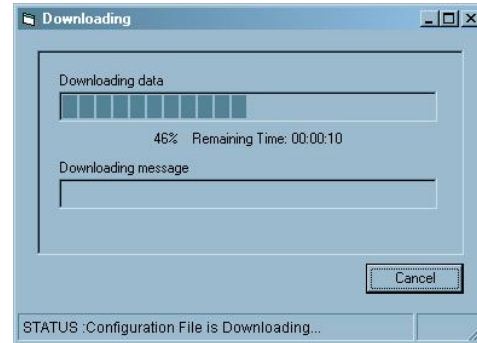
**Configuration download fails.**

When the configuration download fails and the message in the window on the right changes to *STATUS: Downloading data failed* there is a wave file in the configuration with misinterpreted data. The file might be created with Audacity. Files created with R8brain do not suffer from this.
