## 1.0 Version 5.11

### 1.1 Version 5.11 Compatibility

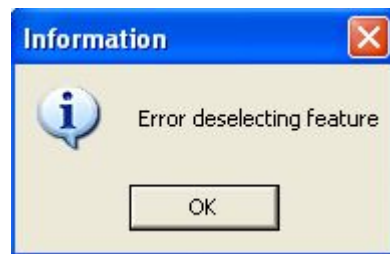
When the “Error deselecting feature” message appears, click **OK** to clear the message.

This message does not interfere with the upgrade, and it appears only when upgrading from RPS 5.9 or RPS 5.10 to RPS 5.11.
