RELEASE NOTE

FireClass 501 Firmware 1.10.23

FireClass 501 Firmware 1.10.15

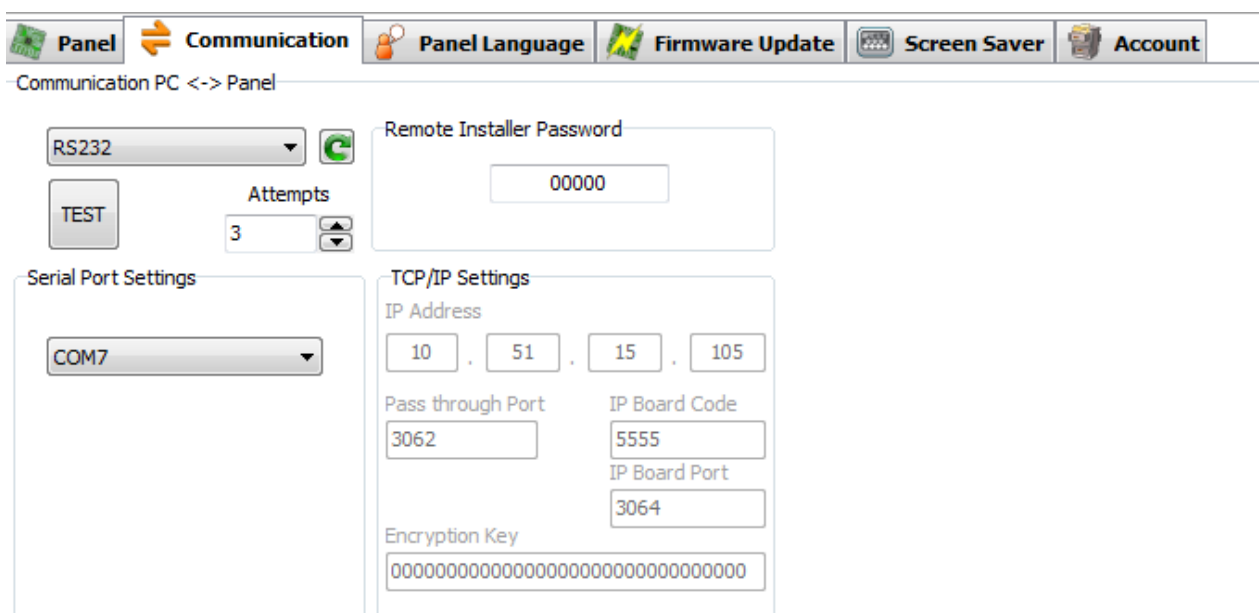
1. Connect the communication cable you are going to use (PC-LINK or USB)
2. Install USB driver when asked (after inserting USB connector on the PC host port) [*ONLY IF YOU ARE GOING TO USE USB CABLE*].
You can find the correct drivers in the FireClass Console SW installation directory (ex: *C:\Program Files\FireClass\FireClass_Console\Drv*). Use "X86" version for 32 bit Windows™ version and "X64" for 64 bit version.
Please be aware that Windows may show a driver security warning. In this case please continue forcing the installation procedure.
3. Go to the FireClass Console Main page -> "Communication" tab and select the channel you are going to use: RS232 (COMx) or USB (USBx)

The screenshot shows the FireClass Console SW interface with the "Communication" tab selected. The interface includes a top navigation bar with tabs: Panel, Communication, Panel Language, Firmware Update, Screen Saver, and Account. Below the navigation bar, the "Communication" section is active, showing a dropdown menu for "RS232" and a "TEST" button. To the right, there is a "Remote Installer Password" field with the value "00000". Below these, there are two main sections: "Serial Port Settings" and "TCP/IP Settings". The "Serial Port Settings" section has a dropdown menu for "COM7". The "TCP/IP Settings" section includes fields for "IP Address" (10.51.15.105), "Pass through Port" (3062), "IP Board Code" (5555), "IP Board Port" (3064), and an "Encryption Key" field with a long string of zeros.
